**Flood Control Project Maintenance  
Levee Inspections**  
**LMA District Cover Sheet**  
**Spring 2020 Levee Inspection Results**

**American River Flood Control District**

**Spring 2020 Levee Inspection Results**

Waterway			Bank	Unit Miles
Unit No. 01 Arcade Creek			Left	2.08
	Spring (March - May)	Summer (June - August)	(September - November) Fall	Winter (December - February)
Unit Maintenance Rating (Fall Only)				
Date of Inspection	3/25/2020 - 3/25/2020			
DWR Inspector	Luz Dial			
Accompanied By	Gilbert Gutierrez ARFCD

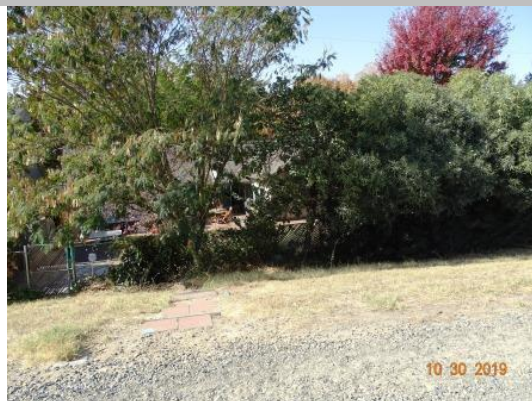
Photo 1 of 1 : SP\_2020\_NA0001\_55\_262\_20200302\_00195.jpg

LM Start	5.50	Rating **	U	Issue No.	262
LM End	5.50	Issue Type +	En	Location *	LS
Category	Earthen Levee			GPS Latitude/Longitude	
				Start	End
Item	Encroachments			38.576796 °	38.576796 °
				-121.423221 °	-121.423221 °
DWR ID	DWR_NA0001_04_s_2017_262				
Comment Code					
FE : Fence					
Inspector Comment					
A chainlink fence with landscaping is obstructing visibility and access at landside levee toe.

View of stairs, landscaping, and fence. Fall 2019

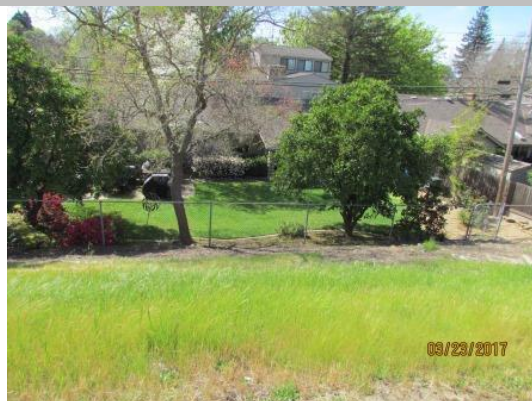
Photo 1 of 1 : SP\_2020\_NA0001\_55\_261\_20200302\_00194.jpg

LM Start	5.51	Rating **	M	Issue No.	261
LM End	5.51	Issue Type +	En	Location *	LS
Category	Earthen Levee			GPS Latitude/Longitude	
				Start	End
Item	Encroachments			38.576579 °	38.576579 °
				-121.423201 °	-121.423201 °
DWR ID	DWR_NA0001_04_s_2017_261				
Comment Code					
FE : Fence					
Inspector Comment					
Chainlink fence and citrus tree at the levee toe do not appear to be permitted, but the paver stairs are authorized under 6480.

View of the fence at the levee toe.

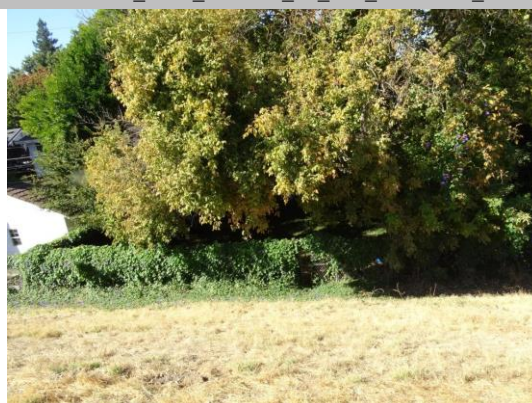
Photo 1 of 1 : SP\_2020\_NA0001\_55\_276\_20200302\_00201.jpg

LM Start	5.58	Rating **	M	Issue No.	276
LM End	5.58	Issue Type +	En	Location *	LS
Category	Earthen Levee			GPS Latitude/Longitude	
				Start	End
Item	Vegetation			38.575565 °	38.575565 °
				-121.423182 °	-121.423182 °
DWR ID	DWR_NA0001_04_f_2018_276				
Comment Code					
V6 : Landscaping					
Inspector Comment					
Vegetation on chainlink fence obstructs the view of the levee toe.

View of vegetation on chainlink fence that obstructs view of levee toe.  
Fall 2018

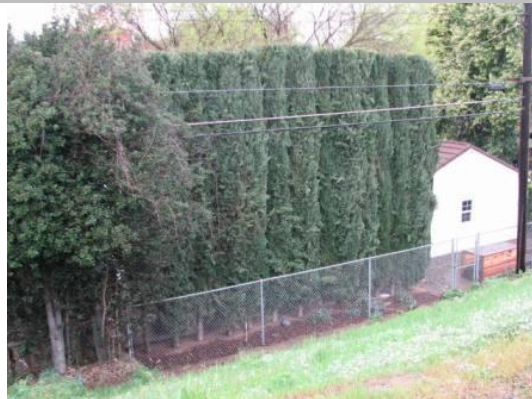
Photo 1 of 1 : SP\_2020\_NA0001\_55\_52\_20200302\_00041.jpg

LM Start	5.60	Rating **	U	Issue No.	52
LM End	5.60	Issue Type +	En	Location *	LS
Category	Earthen Levee			GPS Latitude/Longitude	
				Start	End
Item	Vegetation			38.575379 °	38.575379 °
				-121.423201 °	-121.423201 °
DWR ID	DWR_NA0001_04_s_2012_52				
Comment Code					
V6 : Landscaping					
Inspector Comment					
Helix sky pencil trees within 10-ft of the levee toe obstruct visibility and access.

03/16/2012 Landscaping obstructs visibility and access.

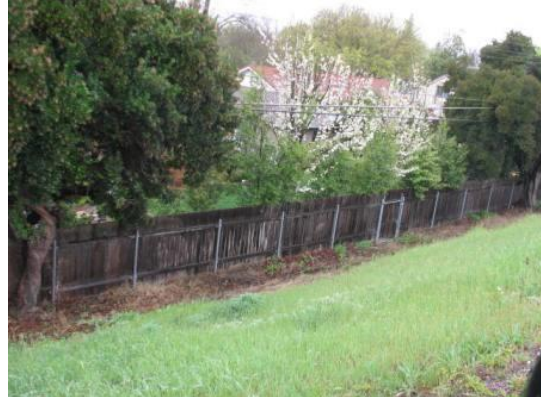
Photo 1 of 1 : SP\_2020\_NA0001\_55\_55\_20200302\_00043.jpg

LM Start	5.64	Rating **	U	Issue No.	55
LM End	5.64	Issue Type +	En	Location *	LS
Category	Earthen Levee			GPS Latitude/Longitude	
				Start	End
Item	Encroachments			38.574786 °	38.574786 °
				-121.423324 °	-121.423324 °
DWR ID	DWR_NA0001_04_s_2012_55				
Comment Code					
FE : Fence					
Inspector Comment					
Wood privacy fence within 10-ft of the levee toe obstructs visibility and does not appear to have a permit.

03/16/2012 Wood privacy fence completely obstructs access and visibility.

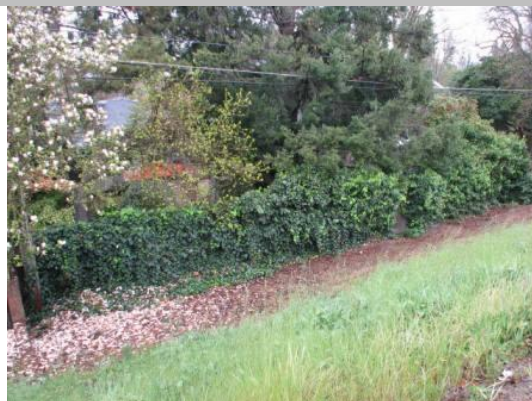
Photo 1 of 1 : SP\_2020\_NA0001\_55\_61\_20200302\_00045.jpg

LM Start	5.78	Rating **	U	Issue No.	61
LM End	5.78	Issue Type +	En	Location *	LS
Category	Earthen Levee			GPS Latitude/Longitude	
				Start	End
Item	Vegetation			38.572827 °	38.572827 °
				-121.423786 °	-121.423786 °
DWR ID	DWR_NA0001_04_s_2012_61				
Comment Code					
V6 : Landscaping					
Inspector Comment					
Dense ivy and shrubs are within 10-ft of the levee toe.

03/16/2012 Landscaping obstructs access and visibility.

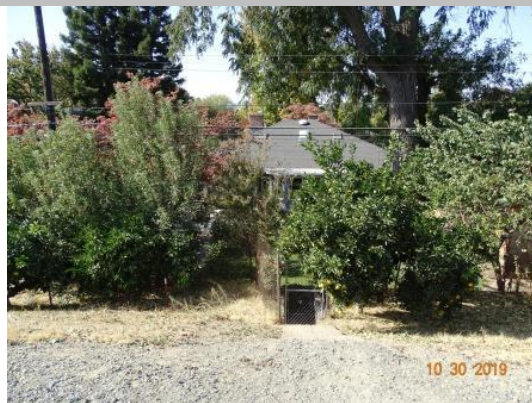
Photo 1 of 1 : SP\_2020\_NA0001\_55\_62\_20200302\_00046.jpg

LM Start	5.80	Rating **	M	Issue No.	62
LM End	5.80	Issue Type +	En	Location *	LS
Category	Earthen Levee			GPS Latitude/Longitude	
				Start	End
Item	Vegetation			38.572542 °	38.572542 °
				-121.423850 °	-121.423850 °
DWR ID	DWR_NA0001_04_s_2012_62				
Comment Code					
V6 : Landscaping					
Inspector Comment					
Citrus trees on the levee slope do not appear to be authorized and block visibility.

View of citrus trees on the levee slope. Fall 2019

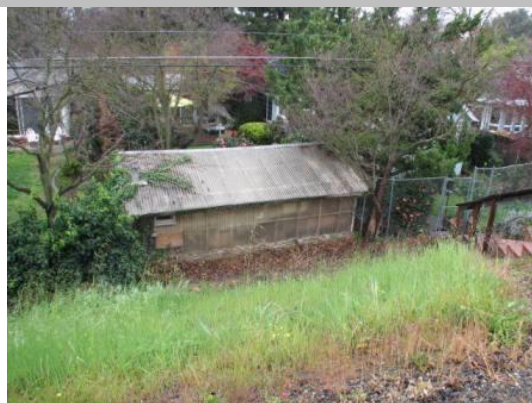
Photo 1 of 1 : SP\_2020\_NA0001\_55\_63\_20200302\_00047.jpg

LM Start	5.81	Rating **	U	Issue No.	63
LM End	5.81	Issue Type +	En	Location *	LS
Category	Earthen Levee			GPS Latitude/Longitude	
				Start	End
Item	Encroachments			38.572325 °	38.572325 °
				-121.423913 °	-121.423913 °
DWR ID	DWR_NA0001_04_s_2012_63				
Comment Code					
BU : Building					
Inspector Comment					
Wood and fiberglass structure is within 10-ft of the levee toe. Chainlink fence and irrigation system do not appear to have a permit.

03/16/2012 Wood and fiberglass structure is within 15' of levee toe.

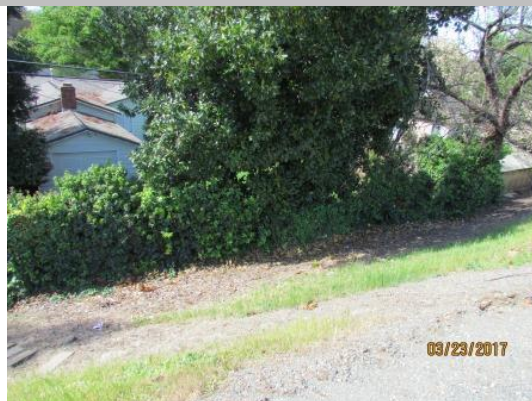
Photo 1 of 1 : SP\_2020\_NA0001\_55\_64\_20200302\_00048.jpg

LM Start	5.82	Rating **	M	Issue No.	64
LM End	5.82	Issue Type +	En	Location *	LS
Category	Earthen Levee			GPS Latitude/Longitude	
				Start	End
Item	Vegetation			38.572207 °	38.572207 °
				-121.423933 °	-121.423933 °
DWR ID	DWR_NA0001_04_s_2012_64				
Comment Code					
V6 : Landscaping					
Inspector Comment					
Dense shrubs on levee toe obstruct visibility.

View of the shrubs at the levee toe. Spring 2017

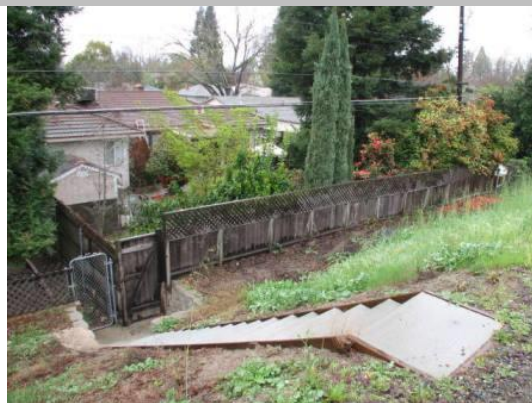
Photo 1 of 1 : SP\_2020\_NA0001\_55\_65\_20200302\_00049.jpg

LM Start	5.83	Rating **	U	Issue No.	65
LM End	5.83	Issue Type +	En	Location *	LS
Category	Earthen Levee			GPS Latitude/Longitude	
				Start	End
Item	Encroachments			38.572067 °	38.572067 °
				-121.423970 °	-121.423970 °
DWR ID	DWR_NA0001_04_s_2012_65				
Comment Code					
FE : Fence					
Inspector Comment					
Extended privacy fence blocks visibility.

03/16/2012 Wood privacy fence completely obstructs access and visibility.

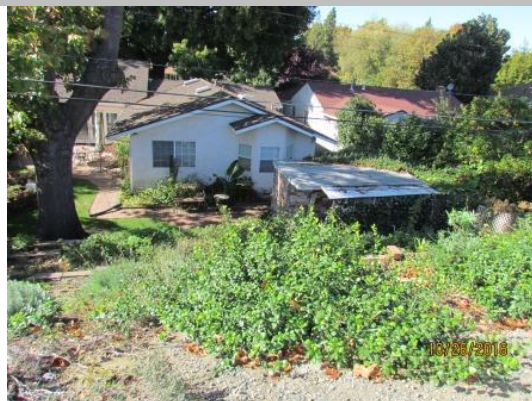
Photo 1 of 1 : SP\_2020\_NA0001\_55\_68\_20200302\_00050.jpg

LM Start	5.87	Rating **	U	Issue No.	68
LM End	5.87	Issue Type +	En	Location *	LS
Category	Earthen Levee			GPS Latitude/Longitude	
				Start	End
Item	Vegetation			38.571525 °	38.571525 °
				-121.424152 °	-121.424152 °
DWR ID	DWR_NA0001_04_s_2018_68				
Comment Code					
V6 : Landscaping					
Inspector Comment					
The levee slope has been landscaped. This obstructs visibility.

Levee slope is heavily landscaped; retaining wall has been constructed at the levee toe.

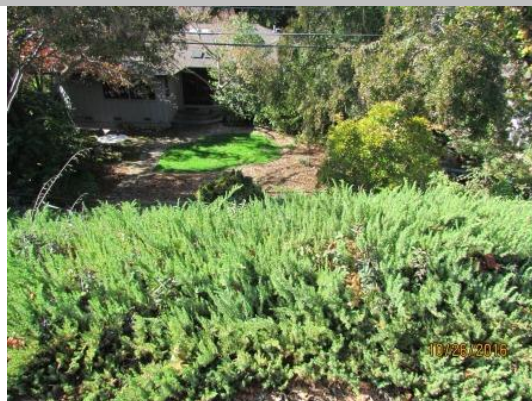
Photo 1 of 1 : SP\_2020\_NA0001\_55\_70\_20200302\_00051.jpg

LM Start	5.88	Rating **	U	Issue No.	70
LM End	5.88	Issue Type +	En	Location *	LS
Category	Earthen Levee			GPS Latitude/Longitude	
				Start	End
Item	Vegetation			38.571269 °	38.571269 °
				-121.424167 °	-121.424167 °
DWR ID	DWR_NA0001_04_s_2012_70				
Comment Code					
V6 : Landscaping					
Inspector Comment					
Levee slope has been landscaped. This obstructs visibility.

View of the vegetation on the landside levee slope. Fall 2016

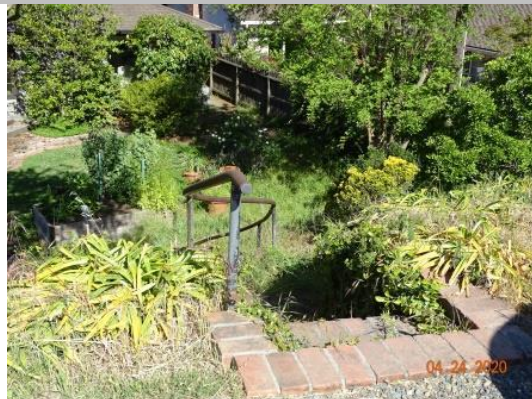
Photo 1 of 1 : SP\_2020\_NA0001\_55\_289\_20200427\_00275.jpg

LM Start	5.89	Rating **	M	Issue No.	289
LM End	5.89	Issue Type +	En	Location *	LS
Category	Earthen Levee			GPS Latitude/Longitude	
				Start	End
Item	Encroachments			38.571235 °	38.571235 °
				-121.424133 °	-121.424133 °
DWR ID	DWR_NA0001_04_s _ 2020_289				
Comment Code					
ST : Stairway					
Inspector Comment					
Stairs with a metal handrail do not appear to be authorized.

View of brick stairs with a metal handrail on the landside slope. Spring 2020

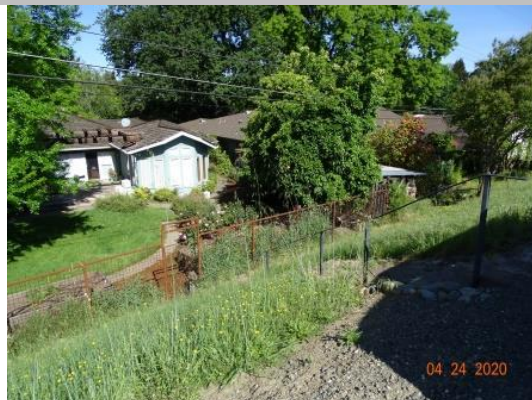
Photo 1 of 1 : SP\_2020\_NA0001\_55\_302\_20200427\_00276.jpg

LM Start	5.90	Rating **	M	Issue No.	302
LM End	5.90	Issue Type +	En	Location *	LS
Category	Earthen Levee			GPS Latitude/Longitude	
				Start	End
Item	Encroachments			38.571060 °	38.571060 °
				-121.424218 °	-121.424218 °
DWR ID	DWR_NA0001_04_s _ 2020_302				
Comment Code					
ST : Stairway					
Inspector Comment					
Stairs with rocks and metal handrail do not appear to be authorized.

View of stairs with a metal handrail on the landside slope. Spring 2020

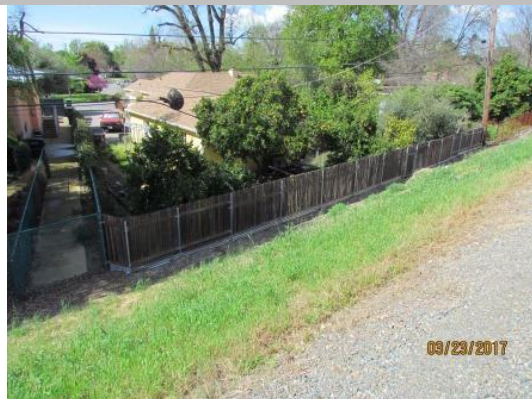
Photo 1 of 1 : SP\_2020\_NA0001\_55\_88\_20200302\_00068.jpg

LM Start	5.91	Rating **	U	Issue No.	88
LM End	5.91	Issue Type +	En	Location *	LS
Category	Earthen Levee			GPS Latitude/Longitude	
				Start	End
Item	Encroachments			38.570864 °	38.570864 °
				-121.424212 °	-121.424212 °
DWR ID	DWR_NA0001_04_f_2012_88				
Comment Code					
FE : Fence					
Inspector Comment					
Wooden privacy fence does not have a permit according to the levee log.

View of the wood privacy fence that completely obstructs access and visibility. Spring 2017

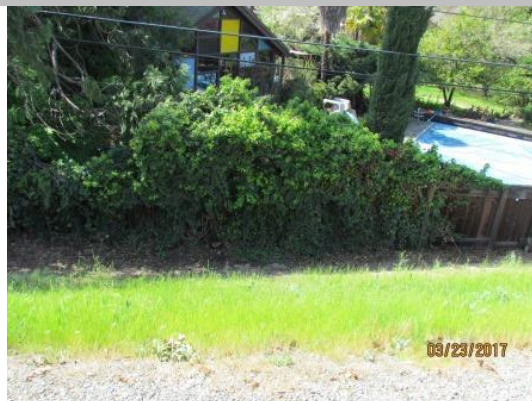
Photo 1 of 1 : SP\_2020\_NA0001\_55\_72\_20200302\_00053.jpg

LM Start	5.95	Rating **	U	Issue No.	72
LM End	5.95	Issue Type +	En	Location *	LS
Category	Earthen Levee			GPS Latitude/Longitude	
				Start	End
Item	Encroachments			38.570389 °	38.570389 °
				-121.424231 °	-121.424231 °
DWR ID	DWR_NA0001_04_s_2012_72				
Comment Code					
FE : Fence					
Inspector Comment					
Wood fence and landscaping within 10-ft of the levee toe obstruct visibility.

View of the wood privacy fence completely obstructing access and visibility.

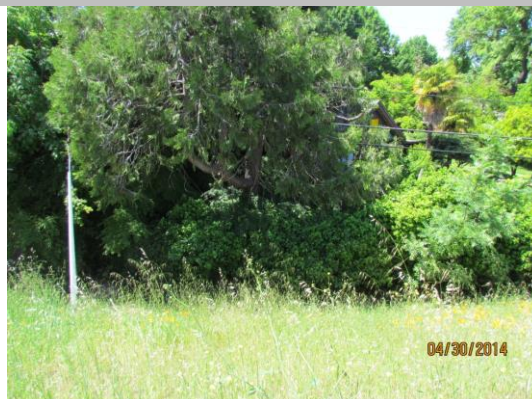
Photo 1 of 1 : SP\_2020\_NA0001\_55\_71\_20200302\_00052.jpg

LM Start	5.95	Rating **	M	Issue No.	71
LM End	5.95	Issue Type +	En	Location *	LS
Category	Earthen Levee			GPS Latitude/Longitude	
				Start	End
Item	Vegetation			38.570375 °	38.570375 °
				-121.424231 °	-121.424231 °
DWR ID	DWR_NA0001_04_s_2012_71				
Comment Code					
V6 : Landscaping					
Inspector Comment					
Landscaping and garden are within 10-ft of the levee toe.

View of the landscaping at the landside levee toe. Spring 2014

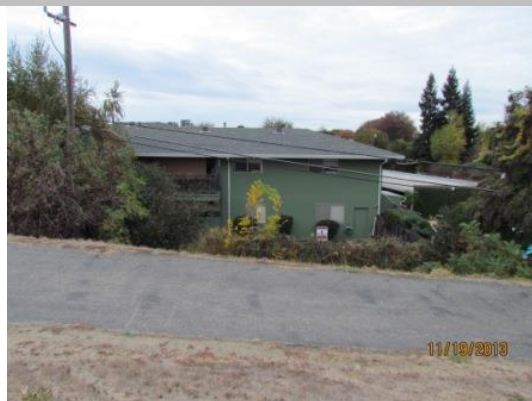
Photo 1 of 1 : SP\_2020\_NA0001\_55\_211\_20200302\_00170.jpg

LM Start	5.98	Rating **	M	Issue No.	211
LM End	5.98	Issue Type +	En	Location *	LS
Category	Earthen Levee			GPS Latitude/Longitude	
				Start	End
Item	Encroachments			38.569893 °	38.569893 °
				-121.424310 °	-121.424310 °
DWR ID	DWR_NA0001_04_s_2012_211				
Comment Code					
FE : Fence					
Inspector Comment					
An apartment complex's privacy fence and shrubs are within 10-ft of the slope and obstruct visibility.

View of the fence at the landside levee toe.

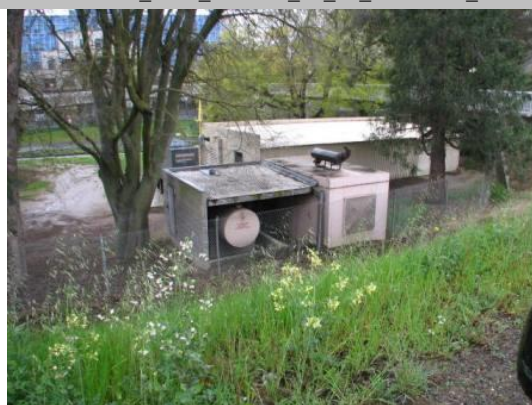
Photo 1 of 1 : SP\_2020\_NA0001\_55\_73\_20200302\_00054.jpg

LM Start	6.58	Rating **	U	Issue No.	73
LM End	6.58	Issue Type +	En	Location *	LS
Category	Earthen Levee			GPS Latitude/Longitude	
				Start	End
Item	Encroachments			38.561643 °	38.561643 °
				-121.421262 °	-121.421262 °
DWR ID	DWR_NA0001_04_s_2012_73				
Comment Code					
BU : Building					
Inspector Comment					
Generator and sheds are within 10-ft of levee slope.

03/16/2012 Structure for generator is within 5' of levee toe.

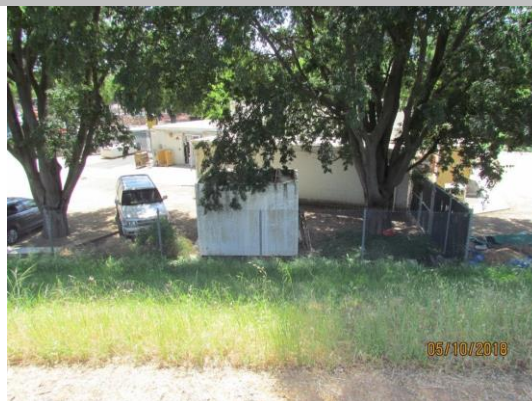
Photo 1 of 1 : SP\_2020\_NA0001\_55\_185\_20200302\_00149.jpg

LM Start	6.60	Rating **	M	Issue No.	185
LM End	6.60	Issue Type +	En	Location *	LS
Category	Earthen Levee			GPS Latitude/Longitude	
				Start	End
Item	Encroachments			38.561448 °	38.561448 °
				-121.421071 °	-121.421071 °
DWR ID	DWR_NA0001_04_s_2018_185				
Comment Code					
BU : Building					
Inspector Comment					
A storage shed is within 10 feet of the landside levee toe.

View of storage shed, Spring 2018.

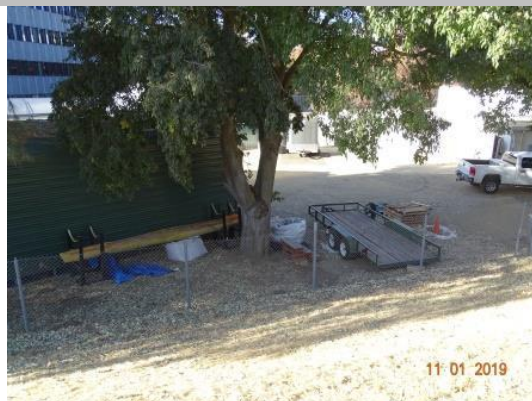
Photo 1 of 1 : SP\_2020\_NA0001\_55\_51\_20200302\_00040.jpg

LM Start	6.62	Rating **	M	Issue No.	51
LM End	6.62	Issue Type +	En	Location *	LS
Category	Earthen Levee			GPS Latitude/Longitude	
				Start	End
Item	Encroachments			38.561117 °	38.561117 °
				-121.420749 °	-121.420749 °
DWR ID	DWR_NA0001_04_f _ 2013_51				
Comment Code					
EQ : Equipment					
Inspector Comment					
A trailer and boat are stored at the levee toe.

View of trailer and boat stored at the landside toe. Fall 2019

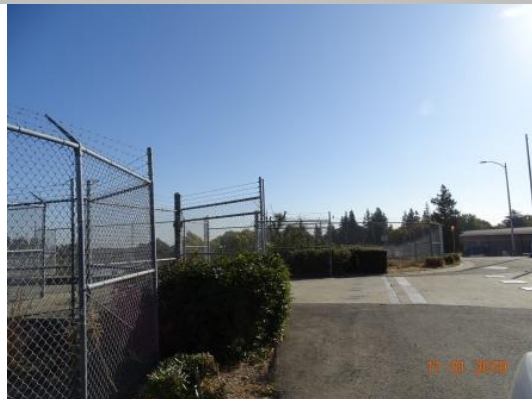
Photo 1 of 1 : SP\_2020\_NA0001\_55\_140\_20200302\_00109.jpg

LM Start	6.88	Rating **	M	Issue No.	140
LM End	6.89	Issue Type +	En	Location *	WS
Category	Earthen Levee			GPS Latitude/Longitude	
				Start	End
Item	Vegetation			38.558592 °	38.558528 °
				-121.417407 °	-121.417248 °
DWR ID	DWR_NA0001_04_f _ 2012_140				
Comment Code					
V6 : Landscaping					
Inspector Comment					
Neet to trim hedges along the levee hinge point at the bridge crossing.

View of landscaping at waterside hinge point. Fall 2019

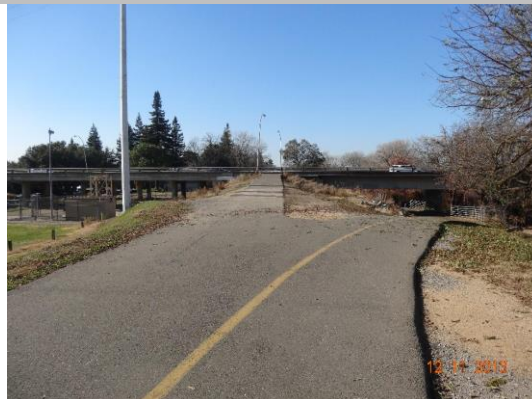
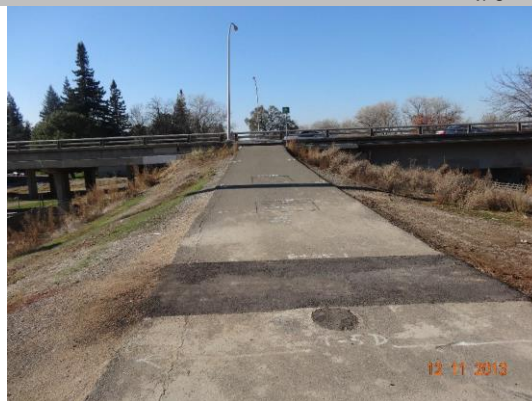
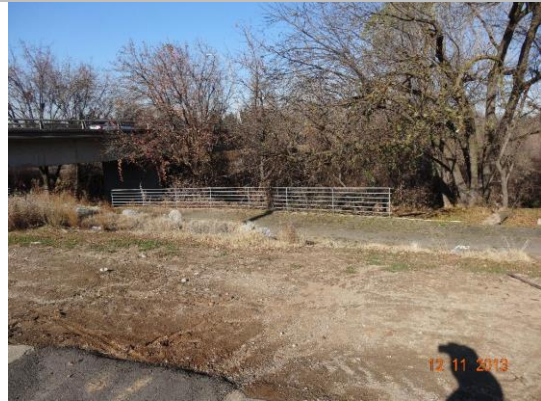
Photo 1 of 3 : UCIP\_SP\_2020\_30023\_55394.jpg

DS\_ID:24319  
FS\_ID:30023  
EP\_NO: 3596  
Repair Type: Non-Urgent  
Crossing Status: Indicator Found  
UCIP Comments: 12/11/2013 Need to contact owners to determine how crossing was abandoned. (DWR UCIP - O. Magana)  
FIELD\_STRUCT\_DESC: \*ABANDONED\* [Sump No. 91] 4 of 4: 48-inch corrugated metal (CM) drainage pipe through the levee, 20 feet below the crown. Pump station is also referenced as the Power Inn Road Plant. Two corrugated metal (CM) cutoff walls around pipe under each shoulder. Slide gate with control pedestal in CM pipe riser located on the waterside (WS) slope. Reinforced concrete discharge box is located on the WS toe. Flap gate is located on the WS end. Slide gate with control pedestal in collection sump located on the landside (LS). 60-inch discharge pipe extends from box across the berm to the riverbank. Pumping plant is located on the LS toe. (48-inch pipe abandoned and CM riser cut 2 feet below ground surface authorized under Permit No. 3596A, 1998 – City of Sacramento; three 30-inch and one 48-inch pipes authorized under Permit No. 3596, 3596A, 1962 - County of Sacramento Manlove Drainage Assessment District; 60-inch pipe authorized under Permit No. 5894, 1970 - City of Sacramento)

Overview of levee crown at crossings.

Signs of crossing repair patch section visible on levee crown.

View of waterward side.

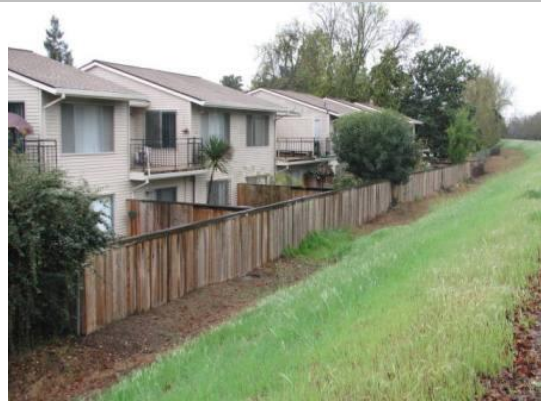
Photo 1 of 1 : SP\_2020\_NA0001\_55\_74\_20200302\_00055.jpg

LM Start	7.65	Rating **	U	Issue No.	74
LM End	7.68	Issue Type +	En	Location *	LS
Category	Earthen Levee			GPS Latitude/Longitude	
				Start	End
Item	Encroachments			38.559177 °	38.559218 °
				-121.403541 °	-121.402967 °
DWR ID	DWR_NA0001_04_s_2012_74				
Comment Code					
FE : Fence					
Inspector Comment					
Wooden privacy fence for seven apartment units is within 10-ft of levee toe and obstructs access and visibility.

03/16/2012 Wood privacy fence completely obstructs access and visibility.

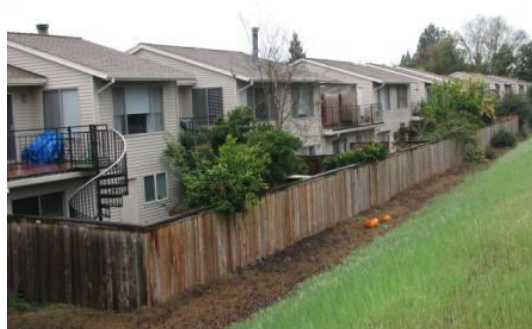
Photo 1 of 1 : SP\_2020\_NA0001\_55\_75\_20200302\_00056.jpg

LM Start	7.69	Rating **	U	Issue No.	75
LM End	7.72	Issue Type +	En	Location *	LS
Category	Earthen Levee			GPS Latitude/Longitude	
				Start	End
Item	Encroachments			38.559230 °	38.559261 °
				-121.402708 °	-121.402219 °
DWR ID	DWR_NA0001_04_s_2012_75				
Comment Code					
FE : Fence					
Inspector Comment					
Wooden privacy fence for seven apartment units is within 10-ft of levee toe and obstructs access and visibility.

03/16/2012 Wood privacy fence completely obstructs access and visibility.

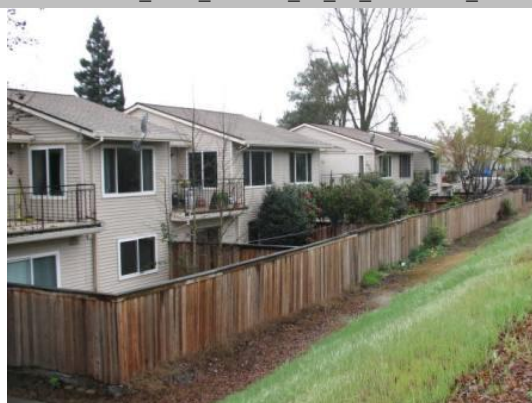
Photo 1 of 1 : SP\_2020\_NA0001\_55\_76\_20200302\_00057.jpg

LM Start	7.73	Rating **	U	Issue No.	76
LM End	7.76	Issue Type +	En	Location *	LS
Category	Earthen Levee			GPS Latitude/Longitude	
				Start	End
Item	Encroachments			38.559277 °	38.559309 °
				-121.401938 °	-121.401388 °
DWR ID	DWR_NA0001_04_s_2012_76				
Comment Code					
FE : Fence					
Inspector Comment					
Wooden privacy fence for seven apartment units is within 10-ft of levee toe and obstructs access and visibility.

03/16/2012 Wood privacy fence completely obstructs access and visibility.

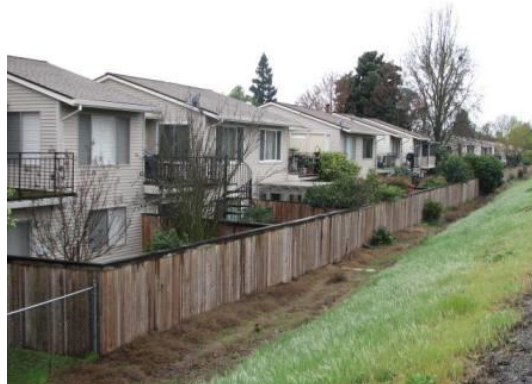
Photo 1 of 1 : SP\_2020\_NA0001\_55\_77\_20200302\_00058.jpg

LM Start	7.78	Rating **	U	Issue No.	77
LM End	7.81	Issue Type +	En	Location *	LS
Category	Earthen Levee			GPS Latitude/Longitude	
				Start	End
Item	Encroachments			38.559330 °	38.559361 °
				-121.401162 °	-121.400606 °
DWR ID	DWR_NA0001_04_s_2012_77				
Comment Code					
FE : Fence					
Inspector Comment					
Wooden privacy fence for seven apartment units is within 10-ft of levee toe and obstructs access and visibility.

03/16/2012 Wood privacy fence completely obstructs access and visibility.

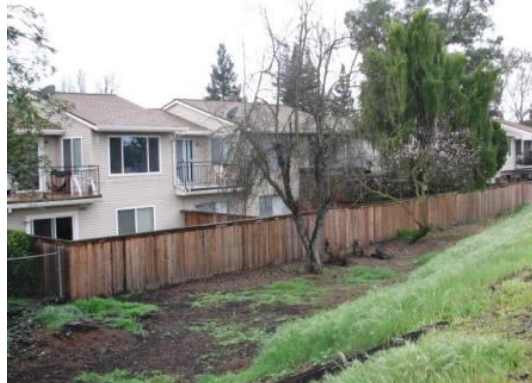
Photo 1 of 1 : SP\_2020\_NA0001\_55\_78\_20200302\_00059.jpg

LM Start	7.82	Rating **	U	Issue No.	78
LM End	7.84	Issue Type +	En	Location *	LS
Category	Earthen Levee			GPS Latitude/Longitude	
				Start	End
Item	Encroachments			38.559379 °	38.559435 °
				-121.400354 °	-121.399944 °
DWR ID	DWR_NA0001_04_s_2017_78				
Comment Code					
FE : Fence					
Inspector Comment					
Wooden privacy fence for seven apartment units is within 10-ft of levee toe and obstructs access and visibility.

03/16/2012 Wood privacy fence completely obstructs access and visibility.

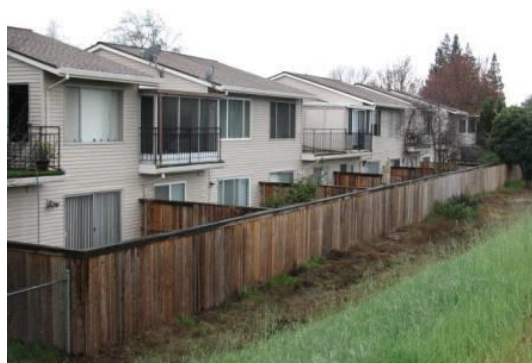
Photo 1 of 1 : SP\_2020\_NA0001\_55\_79\_20200302\_00060.jpg

LM Start	7.88	Rating **	U	Issue No.	79
LM End	7.89	Issue Type +	En	Location *	LS
Category	Earthen Levee			GPS Latitude/Longitude	
				Start	End
Item	Encroachments			38.559628 °	38.559660 °
				-121.399337 °	-121.399078 °
DWR ID	DWR_NA0001_04_s_2012_79				
Comment Code					
FE : Fence					
Inspector Comment					
Wooden privacy fence for seven apartment units is within 10-ft of levee toe and obstructs access and visibility.

03/16/2012 Wood privacy fence completely obstructs access and visibility.

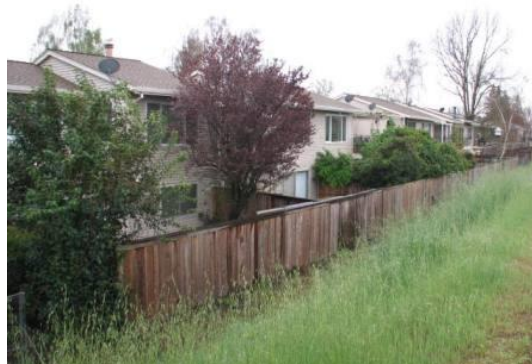
Photo 1 of 1 : SP\_2020\_NA0001\_55\_80\_20200302\_00061.jpg

LM Start	7.90	Rating **	U	Issue No.	80
LM End	7.93	Issue Type +	En	Location *	LS
Category	Earthen Levee			GPS Latitude/Longitude	
				Start	End
Item	Encroachments			38.559753 °	38.559911 °
				-121.398982 °	-121.398506 °
DWR ID	DWR_NA0001_04_s_2012_80				
Comment Code					
FE : Fence					
Inspector Comment					
Wooden privacy fence for seven apartment units is within 10-ft of levee toe and obstructs access and visibility. Concrete steps were also placed on slope.

03/16/2012 Wood privacy fence completely obstructs access and visibility.

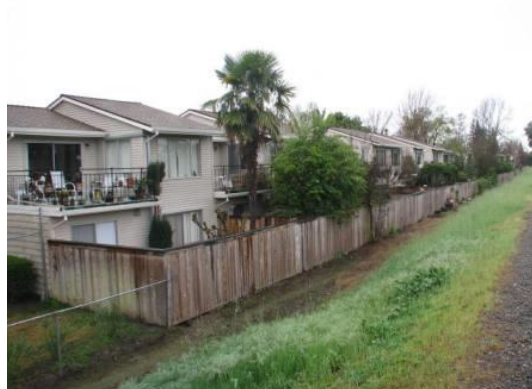
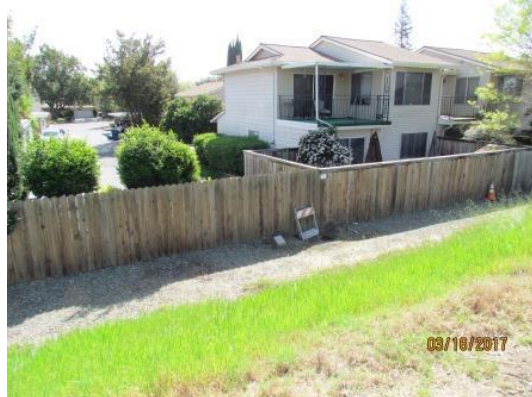
Photo 1 of 2 : SP\_2020\_NA0001\_55\_224\_20200302\_00175.jpg

LM Start	7.94	Rating **	U	Issue No.	224
LM End	8.02	Issue Type +	En	Location *	LS
Category	Earthen Levee			GPS Latitude/Longitude	
				Start	End
Item	Encroachments			38.559968 °	38.560505 °
				-121.398330 °	-121.396989 °
DWR ID	DWR_NA0001_04_s_2012_224				
Comment Code					
FE : Fence					
Inspector Comment					
Wooden privacy fence for seven apartment units is within 10-ft of levee toe and obstructs access and visibility.

03/16/2012 Wood privacy fence completely obstructs access and visibility.

Another view of the fence at the levee toe.

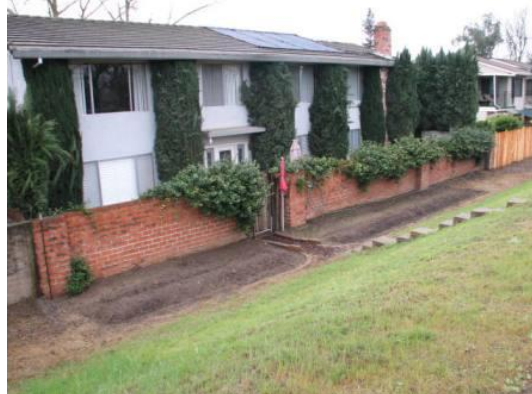
Photo 1 of 1 : SP\_2020\_NA0001\_55\_82\_20200302\_00062.jpg

LM Start	8.02	Rating **	U	Issue No.	82
LM End	8.02	Issue Type +	En	Location *	LS
Category	Earthen Levee			GPS Latitude/Longitude	
				Start	End
Item	Encroachments			38.560537 °	38.560537 °
				-121.396912 °	-121.396912 °
DWR ID	DWR_NA0001_04_s_2012_82				
Comment Code					
FE : Fence					
Inspector Comment					
Brick fence is within 10-ft of levee toe, obstructing access and visibility. Stairs are also on the levee slope.

03/16/2012 Brick wall completely obstructs access and visibility.

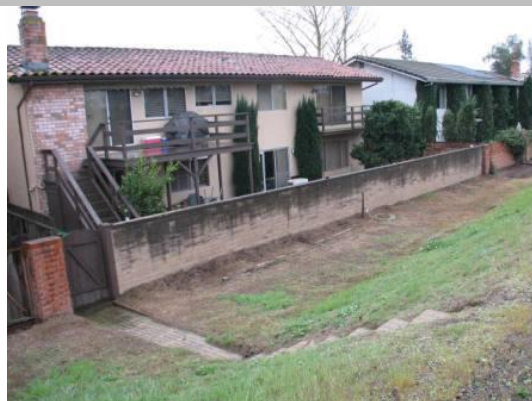
Photo 1 of 1 : SP\_2020\_NA0001\_55\_83\_20200302\_00063.jpg

LM Start	8.04	Rating **	U	Issue No.	83
LM End	8.04	Issue Type +	En	Location *	LS
Category	Earthen Levee			GPS Latitude/Longitude	
				Start	End
Item	Encroachments			38.560647 °	38.560647 °
				-121.396660 °	-121.396660 °
DWR ID	DWR_NA0001_04_s_2012_83				
Comment Code					
FE : Fence					
Inspector Comment					
Brick fence is within 10-ft of levee toe and obstructs access and visibility. Brick stairs do not appear to be permitted.

03/16/2012 Brick wall completely obstructs access and visibility.

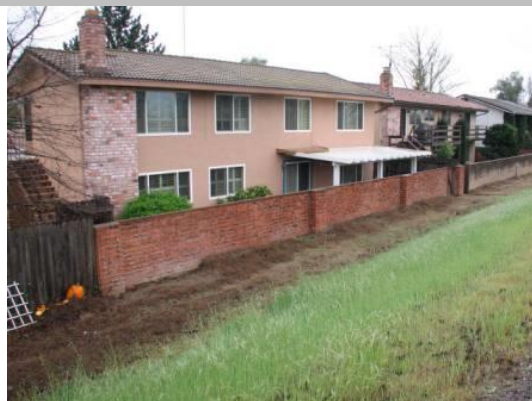
Photo 1 of 1 : SP\_2020\_NA0001\_55\_84\_20200302\_00064.jpg

LM Start	8.05	Rating **	U	Issue No.	84
LM End	8.05	Issue Type +	En	Location *	LS
Category	Earthen Levee			GPS Latitude/Longitude	
				Start	End
Item	Encroachments			38.560728 °	38.560728 °
				-121.396471 °	-121.396471 °
DWR ID	DWR_NA0001_04_s_2012_84				
Comment Code					
FE : Fence					
Inspector Comment					
Brick fence is within 10-ft of levee toe and obstructs access and visibility.

03/16/2012 Brick wall completely obstructs access and visibility.

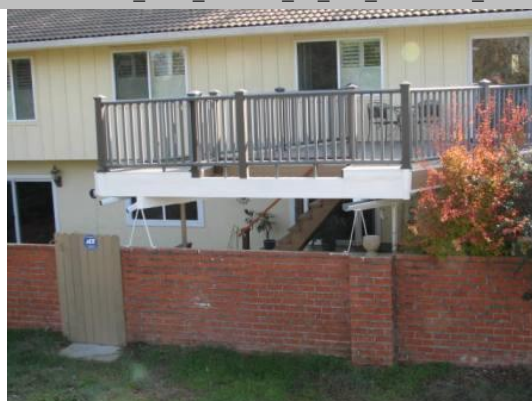
Photo 1 of 1 : SP\_2020\_NA0001\_55\_745\_20200302\_00206.jpg

LM Start	8.07	Rating **	A/W	Issue No.	745
LM End	8.07	Issue Type +	En	Location *	LS
Category	Earthen Levee			GPS Latitude/Longitude	
				Start	End
Item	Encroachments			38.560823 °	38.560823 °
				-121.396208 °	-121.396208 °
DWR ID	DWR_NA0001_04_s_2012_745				
Comment Code					
UR : Urban					
Inspector Comment					
Drains direct gutter flow onto levee toe easement.

11/15/2011 Gutter drains that are suspended from the balcony direct flow onto the levee toe.

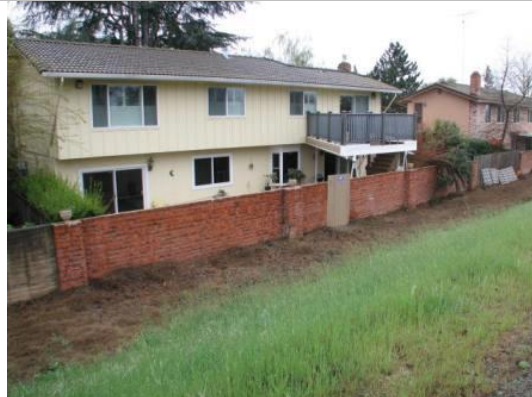
Photo 1 of 1 : SP\_2020\_NA0001\_55\_85\_20200302\_00065.jpg

LM Start	8.07	Rating **	U	Issue No.	85
LM End	8.07	Issue Type +	En	Location *	LS
Category	Earthen Levee			GPS Latitude/Longitude	
				Start	End
Item	Encroachments			38.560845 °	38.560845 °
				-121.396189 °	-121.396189 °
DWR ID	DWR_NA0001_04_f_2019_85				
Comment Code					
FE : Fence					
Inspector Comment					
Brick fence is within 10-ft of levee toe and obstructs access and visibility.

03/16/2012 Brick wall completely obstructs access and visibility.

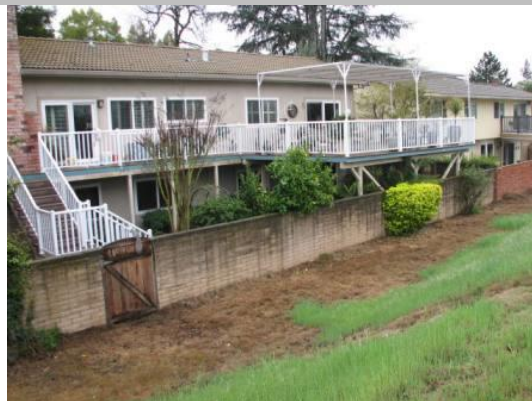
Photo 1 of 1 : SP\_2020\_NA0001\_55\_86\_20200302\_00066.jpg

LM Start	8.08	Rating **	U	Issue No.	86
LM End	8.08	Issue Type +	En	Location *	LS
Category	Earthen Levee			GPS Latitude/Longitude	
				Start	End
Item	Encroachments			38.560907 °	38.560907 °
				-121.396043 °	-121.396043 °
DWR ID	DWR_NA0001_04_s_2012_86				
Comment Code					
FE : Fence					
Inspector Comment					
Brick fence is within 10-ft of levee toe and obstructs access and visibility. Paver stairs do not appear to be authorized.

03/16/2012 Brick wall completely obstructs access and visibility.

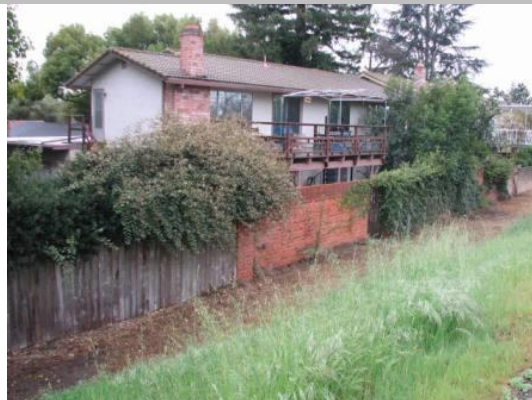
Photo 1 of 1 : SP\_2020\_NA0001\_55\_87\_20200302\_00067.jpg

LM Start	8.09	Rating **	U	Issue No.	87
LM End	8.09	Issue Type +	En	Location *	LS
Category	Earthen Levee			GPS Latitude/Longitude	
				Start	End
Item	Encroachments			38.561008 °	38.561008 °
				-121.395817 °	-121.395817 °
DWR ID	DWR_NA0001_04_s_2012_87				
Comment Code					
FE : Fence					
Inspector Comment					
Brick fence is within 10-ft of levee toe and obstructs access and visibility.

03/16/2012 Brick wall completely obstructs access and visibility.

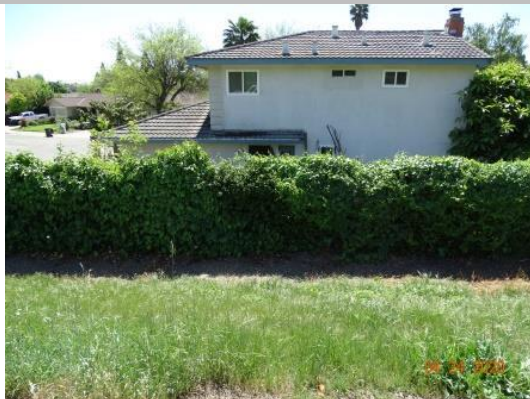
Photo 1 of 1 : SP\_2020\_NA0001\_55\_310\_20200427\_00277.jpg

LM Start	8.12	Rating **	M	Issue No.	310
LM End	8.12	Issue Type +	En	Location *	LS
Category	Earthen Levee			GPS Latitude/Longitude	
				Start	End
Item	Vegetation			38.561202 °	38.561202 °
				-121.395253 °	-121.395253 °
DWR ID	DWR_NA0001_04_s_2020_310				
Comment Code					
V6 : Landscaping					
Inspector Comment					
Vine growth on the fence blocks visibility of the landside toe easement.

View of vines along the fence that obstruct visibility of the landside toe.  
Spring 2020

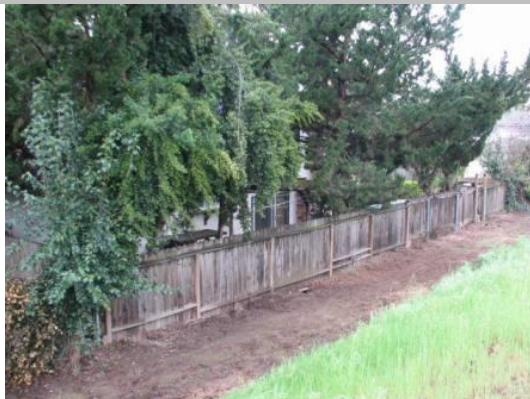
Photo 1 of 1 : SP\_2020\_NA0001\_55\_89\_20200302\_00069.jpg

LM Start	8.14	Rating **	U	Issue No.	89
LM End	8.16	Issue Type +	En	Location *	LS
Category	Earthen Levee			GPS Latitude/Longitude	
				Start	End
Item	Encroachments			38.561338 °	38.561467 °
				-121.395010 °	-121.394728 °
DWR ID	DWR_NA0001_04_s_2012_89				
Comment Code					
FE : Fence					
Inspector Comment					
Fence and landscaping arbor within 10-ft of levee toe obstruct access and visibility.

03/16/2012 Wood privacy fence completely obstructs access and visibility.

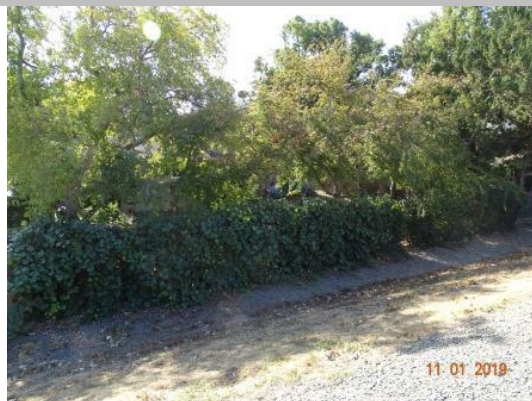
Photo 1 of 1 : SP\_2020\_NA0001\_55\_225\_20200302\_00177.jpg

LM Start	8.16	Rating **	M	Issue No.	225
LM End	8.16	Issue Type +	En	Location *	LS
Category	Earthen Levee			GPS Latitude/Longitude	
				Start	End
Item	Encroachments			38.561455 °	38.561455 °
				-121.394647 °	-121.394647 °
DWR ID	DWR_NA0001_04_f_2019_225				
Comment Code					
FE : Fence					
Inspector Comment					
A chain link fence with vegetation is within 10' of the levee toe and obstructs visibility.

View of a fence with vegetation blocking visibility. Fall 2019

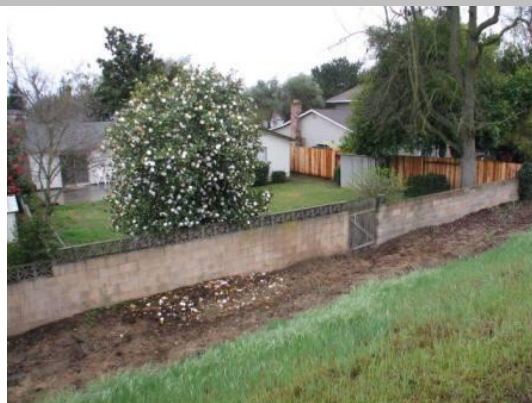
Photo 1 of 1 : SP\_2020\_NA0001\_55\_90\_20200302\_00070.jpg

LM Start	8.17	Rating **	U	Issue No.	90
LM End	8.17	Issue Type +	En	Location *	LS
Category	Earthen Levee			GPS Latitude/Longitude	
				Start	End
Item	Encroachments			38.561544 °	38.561544 °
				-121.394494 °	-121.394494 °
DWR ID	DWR_NA0001_04_s_2019_90				
Comment Code					
FE : Fence					
Inspector Comment					
Cement block fence is within 10-ft of the levee toe.

03/16/2012 Cinder block wall completely obstructs access and visibility.

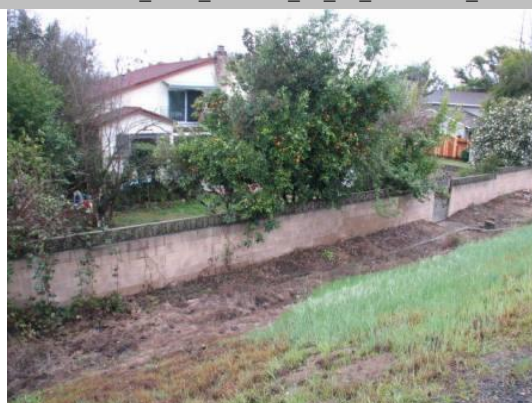
Photo 1 of 1 : SP\_2020\_NA0001\_55\_91\_20200302\_00071.jpg

LM Start	8.18	Rating **	U	Issue No.	91
LM End	8.18	Issue Type +	En	Location *	LS
Category	Earthen Levee			GPS Latitude/Longitude	
				Start	End
Item	Encroachments			38.561593 °	38.561593 °
				-121.394315 °	-121.394315 °
DWR ID	DWR_NA0001_04_s_2012_91				
Comment Code					
FE : Fence					
Inspector Comment					
Concrete block fence and landscaping within 10-ft of levee toe obstruct access and visibility.

03/16/2012 Cinder block wall completely obstructs access and visibility.

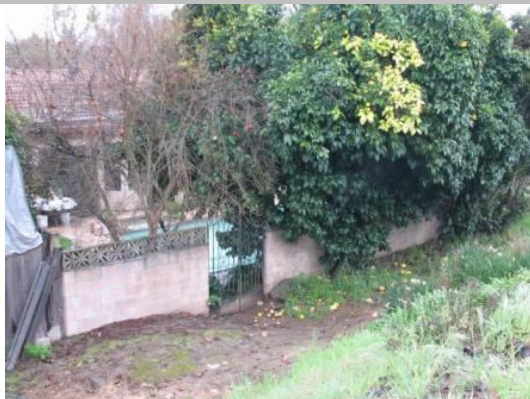
Photo 1 of 1 : SP\_2020\_NA0001\_55\_92\_20200302\_00072.jpg

LM Start	8.19	Rating **	U	Issue No.	92
LM End	8.19	Issue Type +	En	Location *	LS
Category	Earthen Levee			GPS Latitude/Longitude	
				Start	End
Item	Encroachments			38.561658 °	38.561658 °
				-121.394157 °	-121.394157 °
DWR ID	DWR_NA0001_04_s_2012_92				
Comment Code					
FE : Fence					
Inspector Comment					
Cement block fence and landscaping within 10-ft of levee toe obstruct access and visibility.

03/16/2012 Cinder block fence completely obstructs access and visibility.

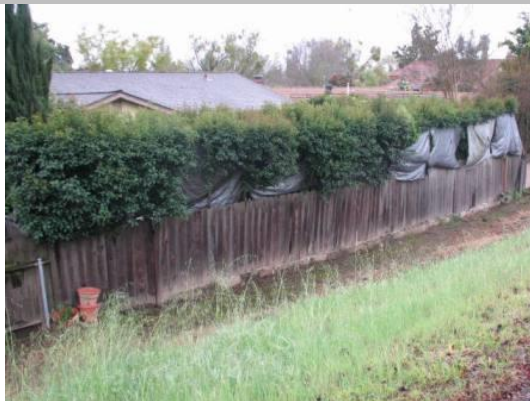
Photo 1 of 1 : SP\_2020\_NA0001\_55\_93\_20200302\_00073.jpg

LM Start	8.21	Rating **	U	Issue No.	93
LM End	8.21	Issue Type +	En	Location *	LS
Category	Earthen Levee			GPS Latitude/Longitude	
				Start	End
Item	Encroachments			38.561750 °	38.561750 °
				-121.393917 °	-121.393917 °
DWR ID	DWR_NA0001_04_s_2012_93				
Comment Code					
FE : Fence					
Inspector Comment					
Wooden fence and landscaping within 10-ft of levee toe obstruct access and visibility.

03/16/2012 Wood privacy fence completely obstructs access and visibility.

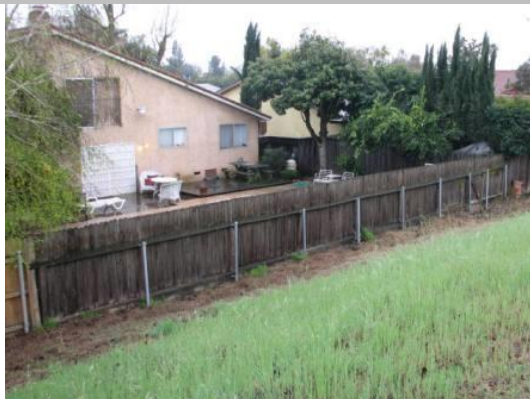
Photo 1 of 1 : SP\_2020\_NA0001\_55\_94\_20200302\_00074.jpg

LM Start	8.22	Rating **	U	Issue No.	94
LM End	8.22	Issue Type +	En	Location *	LS
Category	Earthen Levee			GPS Latitude/Longitude	
				Start	End
Item	Encroachments			38.561820 °	38.561820 °
				-121.393735 °	-121.393735 °
DWR ID	DWR_NA0001_04_s _ 2020_94				
Comment Code					
FE : Fence					
Inspector Comment					
Wood privacy fence and pool within 10-ft of levee toe obstruct access and visibility.

03/16/2012 Wood privacy fence completely obstructs access and visibility.

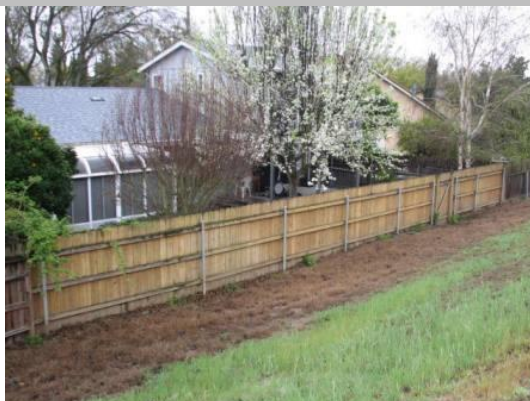
Photo 1 of 1 : SP\_2020\_NA0001\_55\_95\_20200302\_00075.jpg

LM Start	8.23	Rating **	U	Issue No.	95
LM End	8.23	Issue Type +	En	Location *	LS
Category	Earthen Levee			GPS Latitude/Longitude	
				Start	End
Item	Encroachments			38.561900 °	38.561900 °
				-121.393547 °	-121.393547 °
DWR ID	DWR_NA0001_04_s _ 2012_95				
Comment Code					
FE : Fence					
Inspector Comment					
Wood privacy fence within 10-ft of levee toe obstructs access and visibility.

03/16/2012 Wood privacy fence completely obstructs access and visibility.

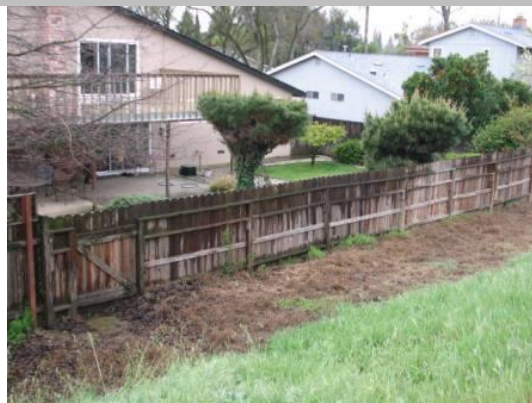
Photo 1 of 1 : SP\_2020\_NA0001\_55\_97\_20200302\_00077.jpg

LM Start	8.24	Rating **	U	Issue No.	97
LM End	8.24	Issue Type +	En	Location *	LS
Category	Earthen Levee			GPS Latitude/Longitude	
				Start	End
Item	Encroachments			38.561977 °	38.561977 °
				-121.393338 °	-121.393338 °
DWR ID	DWR_NA0001_04_s_2017_97				
Comment Code					
FE : Fence					
Inspector Comment					
Wood privacy fence within 10-ft of levee toe obstructs access and visibility.

03/16/2012 Wood privacy fence completely obstructs access and visibility.

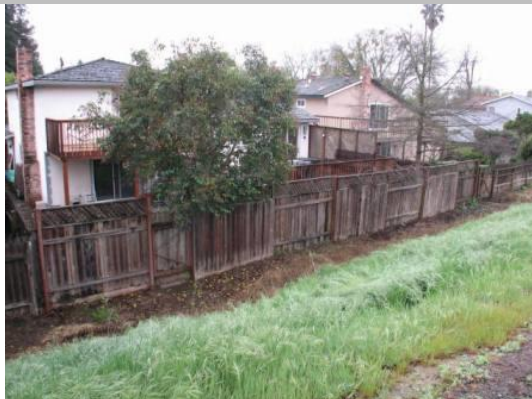
Photo 1 of 1 : SP\_2020\_NA0001\_55\_98\_20200302\_00078.jpg

LM Start	8.25	Rating **	U	Issue No.	98
LM End	8.25	Issue Type +	En	Location *	LS
Category	Earthen Levee			GPS Latitude/Longitude	
				Start	End
Item	Encroachments			38.562054 °	38.562054 °
				-121.393190 °	-121.393190 °
DWR ID	DWR_NA0001_04_s_2012_98				
Comment Code					
FE : Fence					
Inspector Comment					
Wood privacy fence within 10-ft of levee toe obstructs access and visibility.

03/16/2012 Wood privacy fence completely obstructs access and visibility.

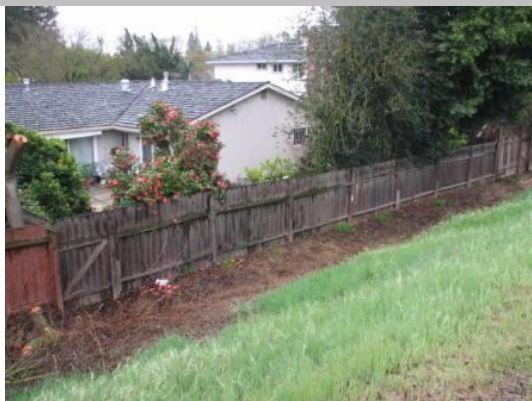
Photo 1 of 1 : SP\_2020\_NA0001\_55\_99\_20200302\_00079.jpg

LM Start	8.26	Rating **	U	Issue No.	99
LM End	8.26	Issue Type +	En	Location *	LS
Category	Earthen Levee			GPS Latitude/Longitude	
				Start	End
Item	Encroachments			38.562120 °	38.562120 °
				-121.392983 °	-121.392983 °
DWR ID	DWR_NA0001_04_s_2012_99				
Comment Code					
FE : Fence					
Inspector Comment					
Wood privacy fence and a shed within 10' of the levee toe obstruct access and visibility.

03/16/2012 Wood privacy fence completely obstructs access and visibility.

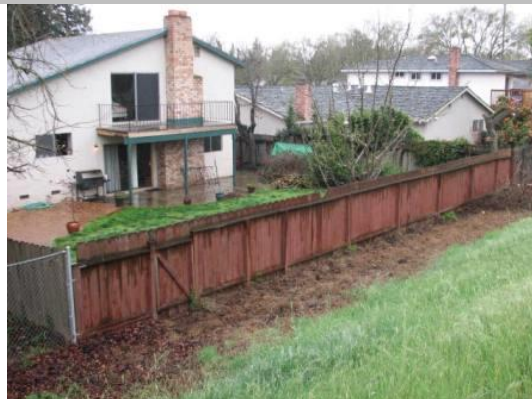
Photo 1 of 1 : SP\_2020\_NA0001\_55\_100\_20200302\_00080.jpg

LM Start	8.27	Rating **	U	Issue No.	100
LM End	8.27	Issue Type +	En	Location *	LS
Category	Earthen Levee			GPS Latitude/Longitude	
				Start	End
Item	Encroachments			38.562182 °	38.562182 °
				-121.392778 °	-121.392778 °
DWR ID	DWR_NA0001_04_s_2012_100				
Comment Code					
FE : Fence					
Inspector Comment					
Wood privacy fence within 10-ft of levee toe obstructs access and visibility.

03/16/2012 Wood privacy fence completely obstructs access and visibility.

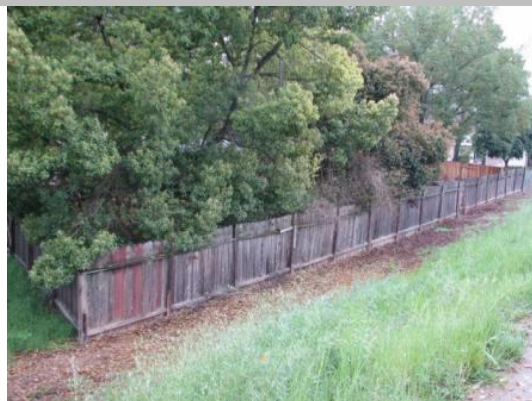
Photo 1 of 1 : SP\_2020\_NA0001\_55\_101\_20200302\_00081.jpg

LM Start	8.32	Rating **	U	Issue No.	101
LM End	8.32	Issue Type +	En	Location *	LS
Category	Earthen Levee			GPS Latitude/Longitude	
				Start	End
Item	Encroachments			38.562508 °	38.562508 °
				-121.392037 °	-121.392037 °
DWR ID	DWR_NA0001_04_s_2012_101				
Comment Code					
FE : Fence					
Inspector Comment					
Wood privacy fence within 10-ft of levee toe obstructs access and visibility.

03/16/2012 Wood privacy fence completely obstructs access and visibility.

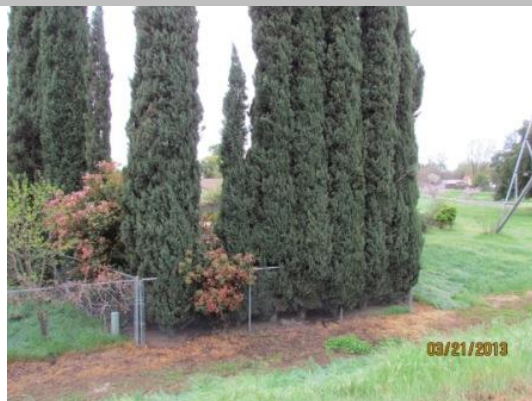
Photo 1 of 1 : SP\_2020\_NA0001\_55\_102\_20200302\_00082.jpg

LM Start	8.38	Rating **	M	Issue No.	102
LM End	8.38	Issue Type +	En	Location *	LS
Category	Earthen Levee			GPS Latitude/Longitude	
				Start	End
Item	Vegetation			38.562889 °	38.562889 °
				-121.391042 °	-121.391042 °
DWR ID	DWR_NA0001_04_s_2012_102				
Comment Code					
V6 : Landscaping					
Inspector Comment					
Helix sky pencil along chain link fence is within 10-ft of the levee toe.

View of the landscaping at the levee toe. Spring 2013

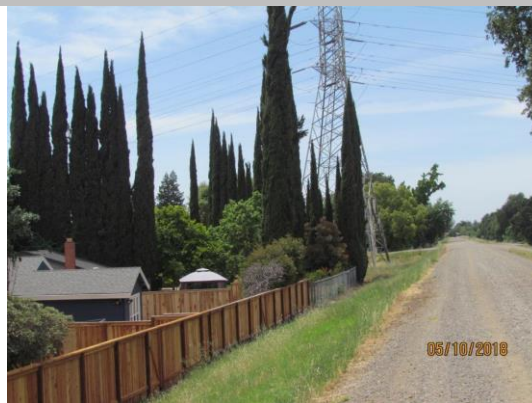
Photo 1 of 1 : SP\_2020\_NA0001\_55\_103\_20200302\_00083.jpg

LM Start	8.40	Rating **	U	Issue No.	103
LM End	8.41	Issue Type +	En	Location *	LS
Category	Earthen Levee			GPS Latitude/Longitude	
				Start	End
Item	Encroachments			38.563042 °	38.563083 °
				-121.390692 °	-121.390600 °
DWR ID	DWR_NA0001_04_s_2012_103				
Comment Code					
FE : Fence					
Inspector Comment					
Wood privacy fence within 10-ft of levee toe obstructs access and visibility.

View looking downstream landside of the wood privacy fence that completely obstructs access and visibility, Spring 2018.

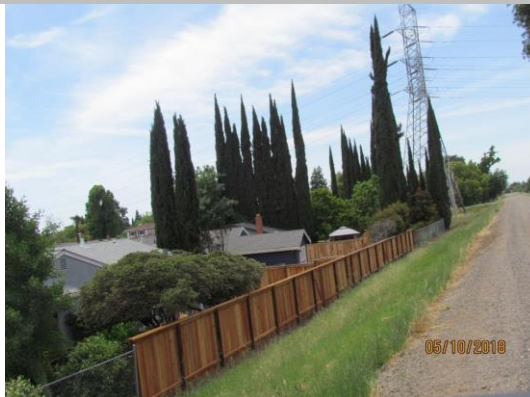
Photo 1 of 1 : SP\_2020\_NA0001\_55\_104\_20200302\_00084.jpg

LM Start	8.42	Rating **	U	Issue No.	104
LM End	8.42	Issue Type +	En	Location *	LS
Category	Earthen Levee			GPS Latitude/Longitude	
				Start	End
Item	Encroachments			38.563129 °	38.563129 °
				-121.390406 °	-121.390406 °
DWR ID	DWR_NA0001_04_s_2012_104				
Comment Code					
FE : Fence					
Inspector Comment					
Wood privacy fence within 10-ft of levee toe obstructs access and visibility.

View looking downstream landside of the wood privacy fence that completely obstructs access and visibility, Spring 2018.

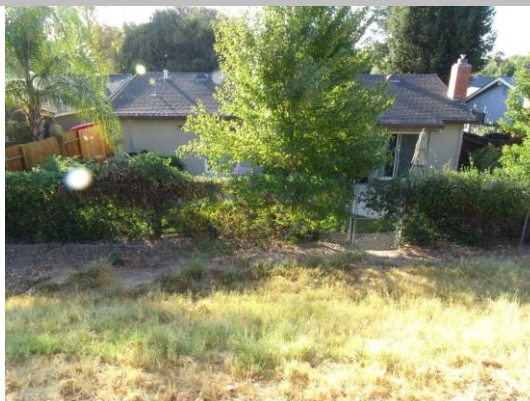
Photo 1 of 1 : SP\_2020\_NA0001\_55\_258\_20200302\_00193.jpg

LM Start	8.43	Rating **	M	Issue No.	258
LM End	8.43	Issue Type +	En	Location *	LS
Category	Earthen Levee			GPS Latitude/Longitude	
				Start	End
Item	Vegetation			38.563208 °	38.563208 °
				-121.390226 °	-121.390226 °
DWR ID	DWR_NA0001_04_f_2018_258				
Comment Code					
V6 : Landscaping					
Inspector Comment					
Vines on chainlink fence block visibility of levee toe.

View of vines on fence that block visibility of levee toe. Fall 2018

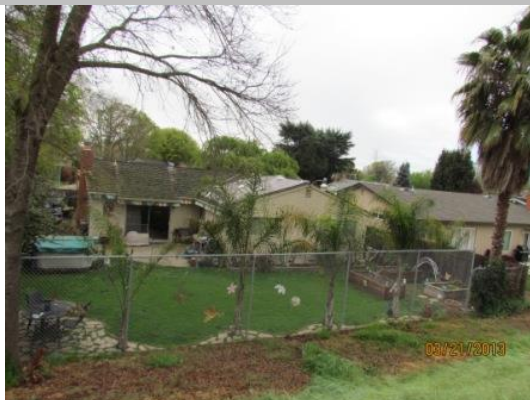
Photo 1 of 1 : SP\_2020\_NA0001\_55\_105\_20200302\_00085.jpg

LM Start	8.44	Rating **	M	Issue No.	105
LM End	8.44	Issue Type +	En	Location *	LS
Category	Earthen Levee			GPS Latitude/Longitude	
				Start	End
Item	Vegetation			38.563238 °	38.563238 °
				-121.390073 °	-121.390073 °
DWR ID	DWR_NA0001_04_s_2012_105				
Comment Code					
V6 : Landscaping					
Inspector Comment					
Palms were planted within 10-ft of the levee toe.

View of the palm trees at the levee toe. Spring 2013

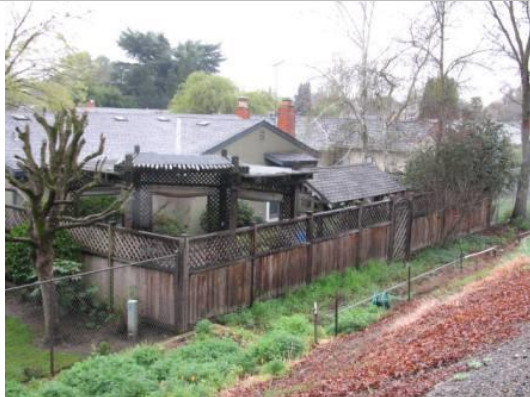
Photo 1 of 1 : SP\_2020\_NA0001\_55\_106\_20200302\_00086.jpg

LM Start	8.45	Rating **	U	Issue No.	106
LM End	8.45	Issue Type +	En	Location *	LS
Category	Earthen Levee			GPS Latitude/Longitude	
				Start	End
Item	Encroachments			38.563308 °	38.563308 °
				-121.389885 °	-121.389885 °
DWR ID	DWR_NA0001_04_s_2012_106				
Comment Code					
FE : Fence					
Inspector Comment					
Wood privacy fence within 10-ft of levee toe obstructs access and visibility.

03/16/2012 Wood privacy fence completely obstructs access and visibility.

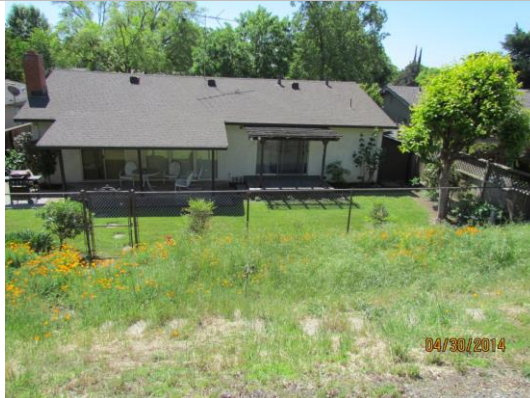
Photo 1 of 1 : SP\_2020\_NA0001\_55\_246\_20200302\_00189.jpg

LM Start	8.46	Rating **	M	Issue No.	246
LM End	8.46	Issue Type +	En	Location *	LS
Category	Earthen Levee			GPS Latitude/Longitude	
				Start	End
Item	Encroachments			38.563434 °	38.563434 °
				-121.389675 °	-121.389675 °
DWR ID	DWR_NA0001_04_s_2014_246				
Comment Code					
RW : Retaining Wall					
Inspector Comment					
Retaining wall, concrete steps, orange tree, and irrigation lines are within the landside levee toe easement.

View of the irrigation and retaining wall at the landside levee toe.
